UNUSUAL ENGINEERING FEATURES OF  
THE AL MALAIKAH TEMPLE,  
LOS ANGELES

JOHN C. AUSTIN, *Architect*

By R. McC. BEANFIELD, Assoc. M. Am. Soc. C. E.,  
*Consulting Engineer*

Reprinted from the May 5, 1928 issue of  
**The American Architect**

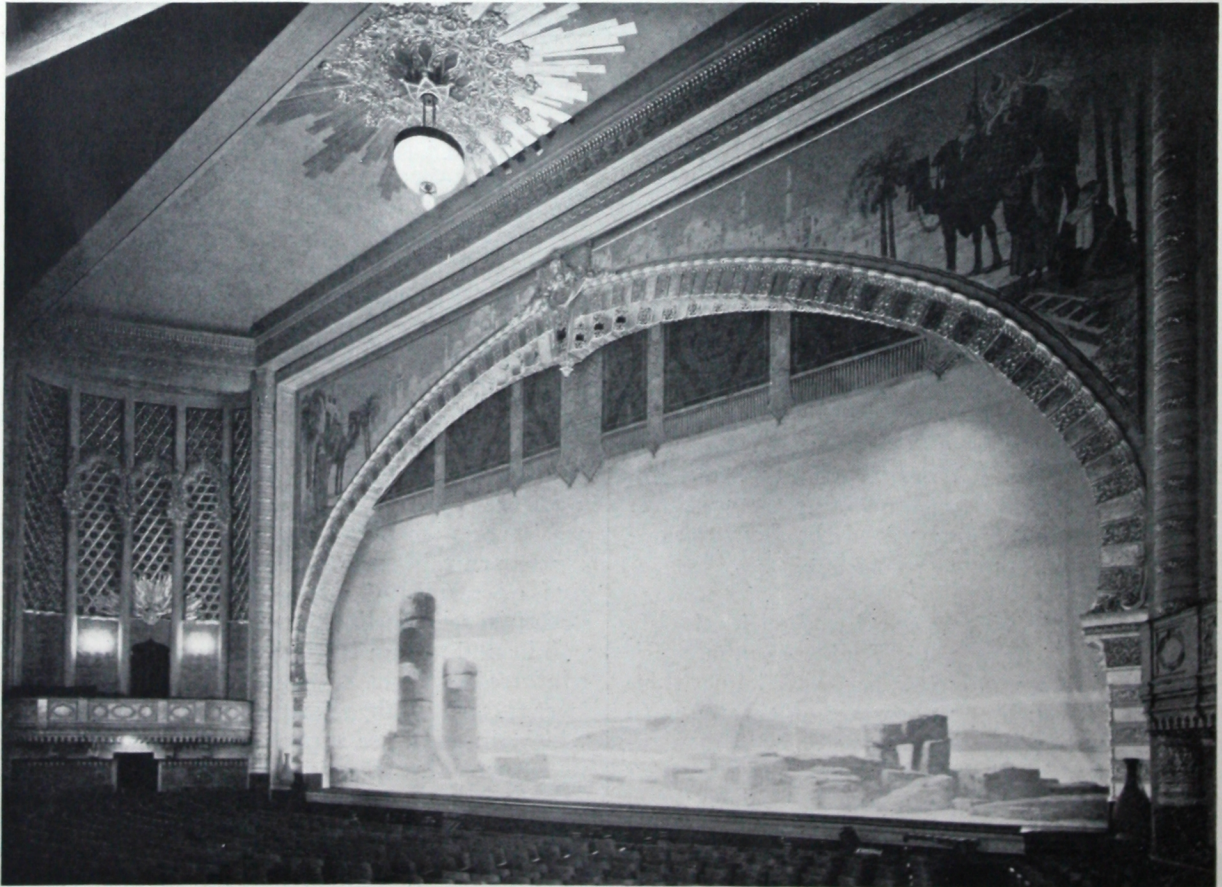
THE PROSCENIUM OPENING HAS A CLEAR SPAN OF 100 FT. AND A HEIGHT OF 37 FT. AT THE CROWN. AMPLIFYING SPEAKERS ARE CONCEALED IN THE JEWELLED CROWN OF THE ARCH

The proscenium arch, constructed of reinforced concrete, has a clear span of 100 ft. This arch was computed as a girder with partly restrained ends with diagonal tension stresses resisted by diagonal bars. In order to increase the lateral stiffness, pilasters were placed in the web under each roof arch similar to the stiffeners in plate girder construction. A flanged head, or tee, in the top of the proscenium girder also adds to its lateral stiffness.

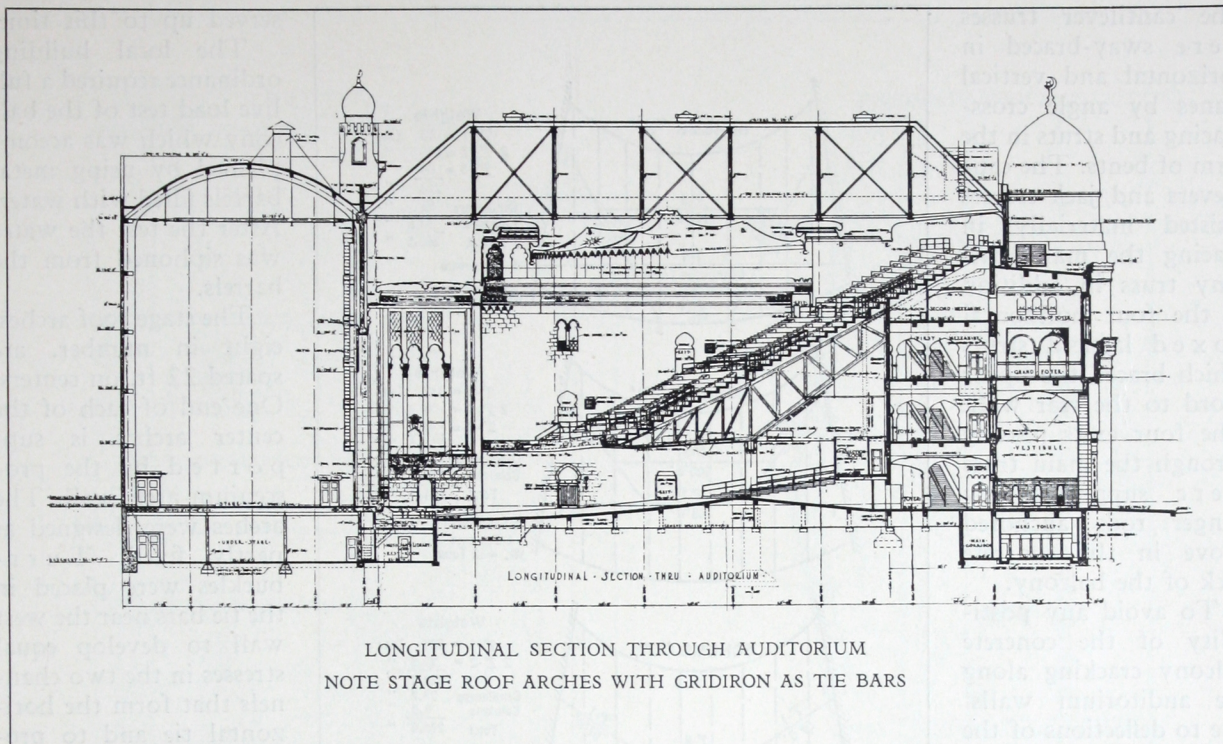
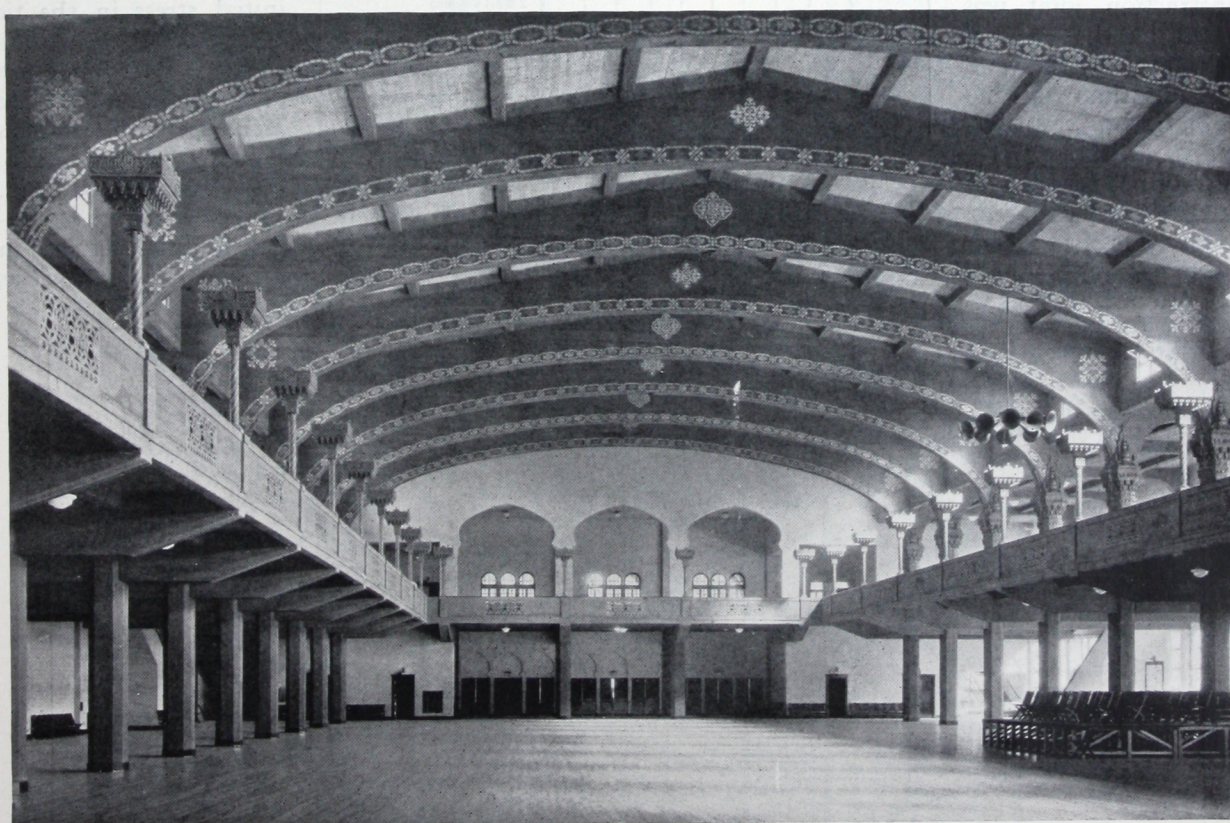
THE ROOF OVER THE BANQUET HALL IS SUPPORTED ON REINFORCED CONCRETE ARCHES OF 90 FT. CLEAR SPAN. BENDING STRESSES IN COLUMNS ARE REDUCED BY THE CANTILEVERED BALCONY. DECORATIONS ARE PAINTED ON CONCRETE

The continuous reinforced concrete girders, supporting the banquet hall roof, were designed as a part of a fixed frame. The soffits of the roof girders were curved to represent Saracenic arches, which added to the depth of the girders over the interior columns where large negative moments existed. The use of balcony cantilever girders tended to reduce the moments in the columns. The rear, or wall, columns were required to resist an uplift. The anchor arms of the continuous girders were projected through and above the roof, being hidden from the interior.

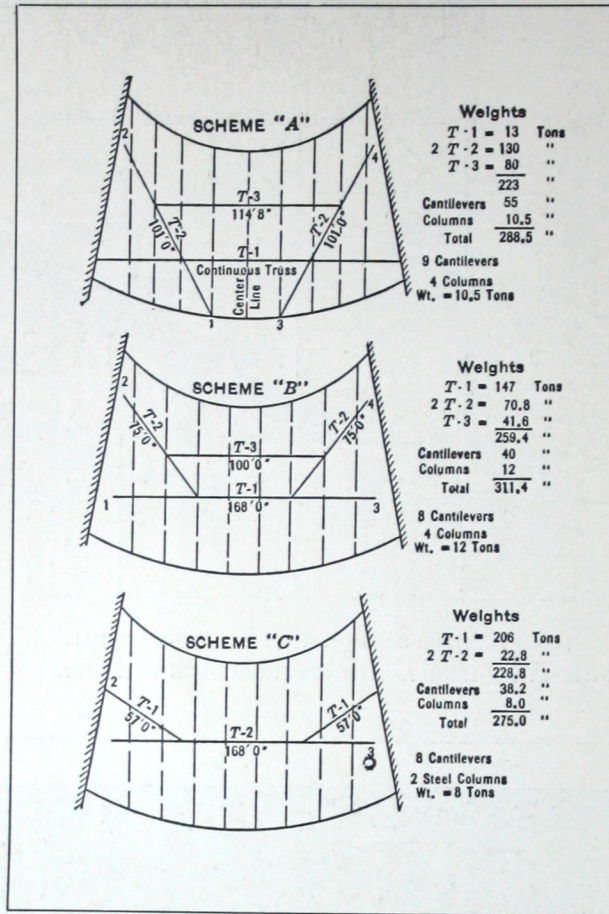
PRELIMINARY DESIGNS AND ESTIMATES WERE MADE FOR THREE DIFFERENT SYSTEMS OF BALCONY TRUSS FRAMING. SCHEME C WAS SELECTED AS BEING THE MOST PRACTICAL, ECONOMICAL AND RATIONAL

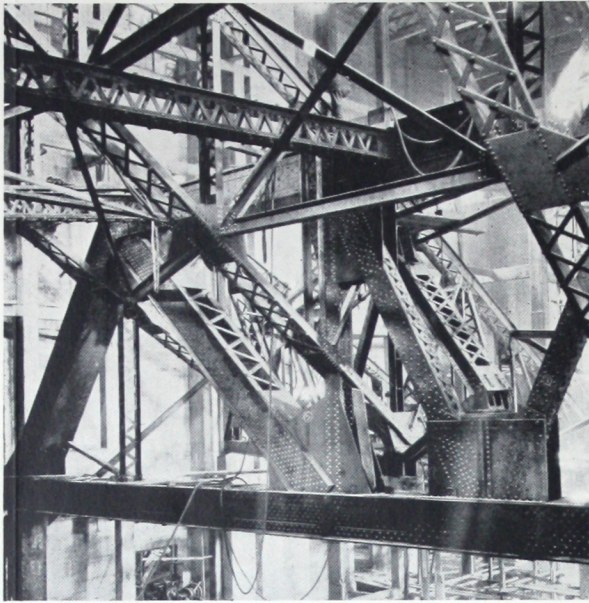
MAIN BALCONY TRUSS SHOWING PIN COLUMN CONNECTION AND PIN CONNECTION OF JACK TRUSS TO STEEL CASTING ON MAIN TRUSS. ABOUT 30% OF HOLES IN CONNECTIONS WERE BOLTED TIGHT BEFORE ONE INCH TAPERED RIVETS WERE DRIVEN UNDER 120-LB. PRESSURE

Jack truss T-1 is attached at one end to the main balcony truss by a pin connection in a large steel casting resting on a built-up stool between the web members of truss T-2. The other end is supported on a reinforced concrete wall column. The chords of truss T-1 consist of two 15-in. channels, with 8-in. H web members. The bottom chord in the end panel section of the balcony truss, T-1, was composed of two 8-in. standard eye-bars to avoid clearance difficulties. The pin joint connecting truss T-1 to the main balcony truss, T-2, eliminated any possibility of excessive restraining moments due to the varying deformations of the connected trusses.

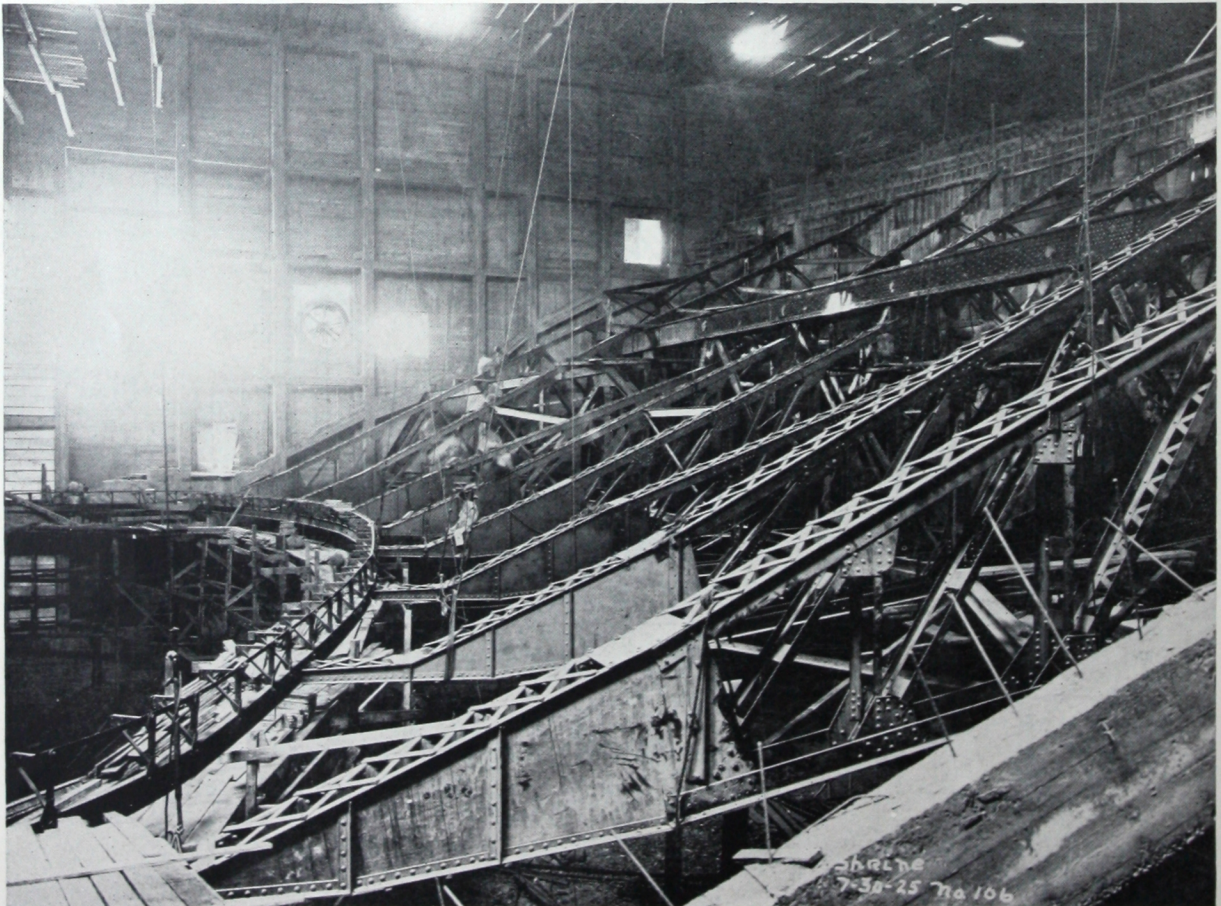
OUTER ENDS OF BALCONY CANTILEVER TRUSSES WERE SUPPORTED BY CABLES FROM ROOF TRUSSES BEFORE RIVETING. PLATE GIRDER ENDS OF CANTILEVERS ARE USED TO REDUCE DEFLECTION AT OUTER END

In order to stiffen the ends of the cantilever trusses and reduce their deflections to a minimum, a double web plate girder section was used. During erection, the plate girder sections were given a camber by offsetting the rivet holes in the bottom chord in the joint connecting them to the open web section of the truss. The chords were built of 8 by 3-in. angles, latticed and placed 1 ft. 3 in., back to back, which width added to the lateral stiffness. The anchor, or wall, ends of the cantilever trusses were secured to anchor-bolts on top of reinforced columns.

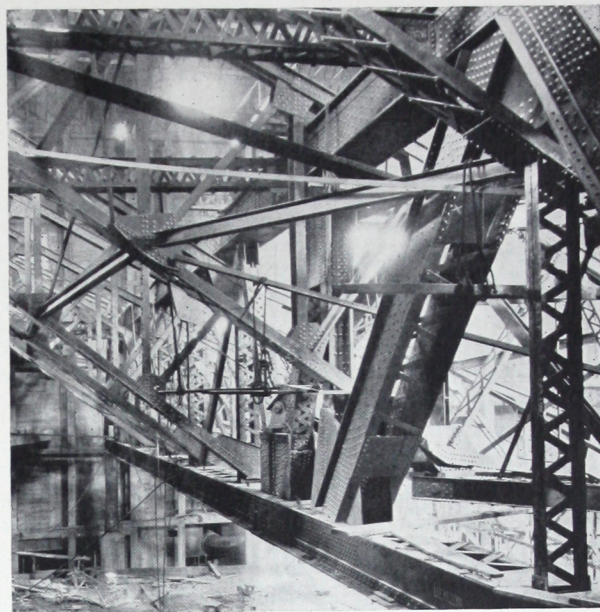
MAIN BALCONY TRUSS SHOWING INTRICACY OF CONNECTION DETAILS AND PIN CONNECTION OF JACK TRUSS TO STEEL CASTING ON MAIN TRUSS. ELECTRIC WELDING WAS USED TO OBTAIN METAL-TO-METAL CONTACT WHERE INCLINED SURFACES MADE IT DIFFICULT TO MILL ACCURATELY

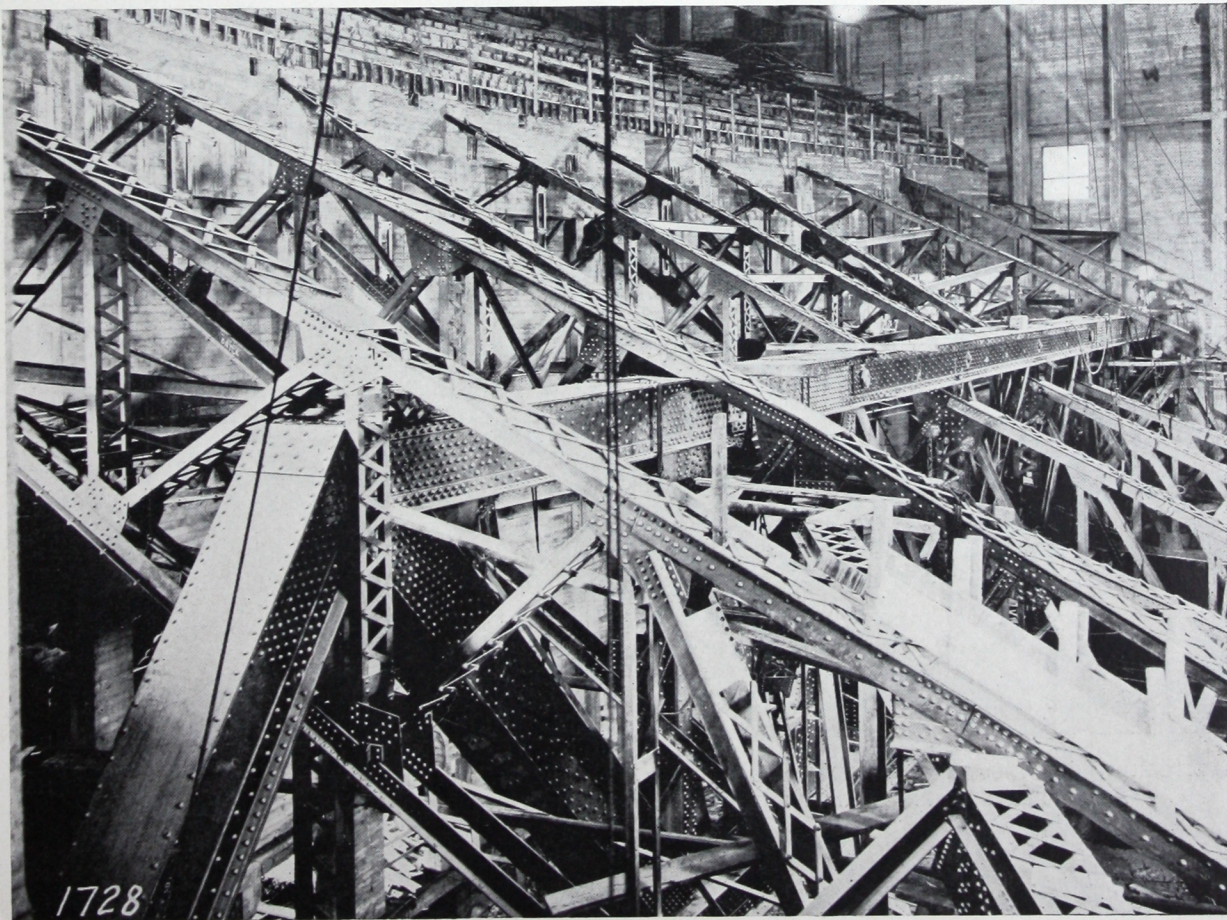
MAIN BALCONY TRUSS AND CANTILEVERS. CANTILEVERS WERE HOISTED TO CAMBERED POSITION. HOLES WERE DRILLED AND MATCHED BEFORE RIVETING. NOTE PIN JOINTS IN UPPER CHORD

As it is necessary to have sufficient clearance through the center part of this main truss for the balcony exit passageways, pin joints and eye-bar diagonals were used instead of the usual built-up members and riveted joints with larger gusset-plates. Riveted joints were used where practicable to obtain general stiffness. Where pins were necessary, nickel steel was chosen, particularly, to reduce the size of the pin-holes in the lower chord.

The balcony truss was delivered to the job in sections, the largest (center lower chord section) weighing 47 tons and being 80 ft. long. The truss was erected on a steel substructure consisting of the same members as were used in the falsework for the roof trusses. The lower chord sections were first set on camber screw-jacks. The web members were next placed, and followed by the top chord sections.

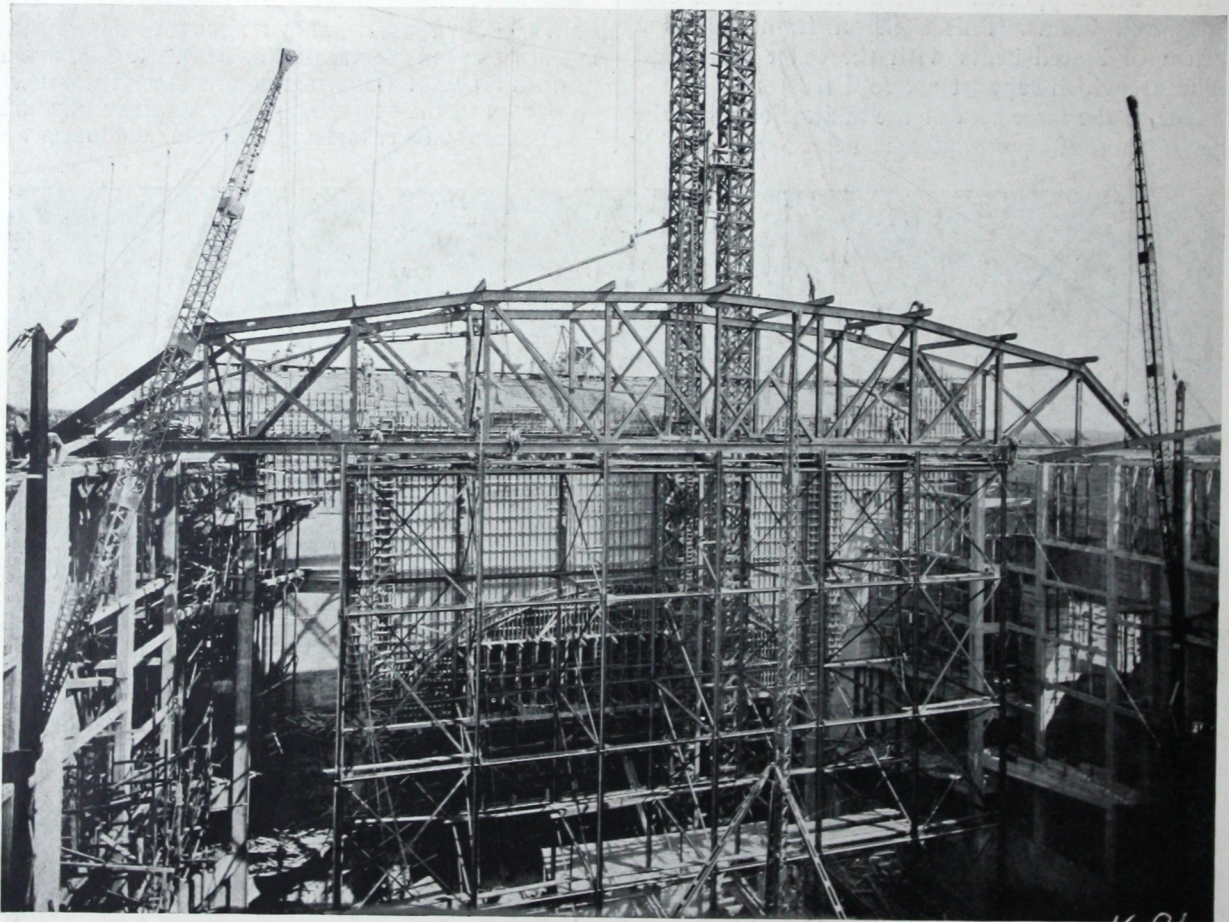
AUDITORIUM ROOF TRUSSES WEIGH 60 TONS EACH AND SPAN 192 FT. ONE END IS ON ROLLERS. ANCHOR END HAS A LEAD PLATE BEARING TO PREVENT ECCENTRIC LOADING ON REINFORCED CONCRETE COLUMNS

The structural steel roof trusses over the auditorium, each weighing 60 tons, have a clear span of 192 ft. and rest on reinforced concrete columns.

The south ends of the roof trusses were anchored; the north ends were set on nests of rollers. This provided an excellent structural connection for earthquake resistance. The roller bearings allow the roof and supporting trusses to move (horizontal translation) independently of the north supports with temperature variation, which is also a favorable structural condition of flexibility for relieving seismic stresses. If the roof trusses had been anchored at both ends, they would act like battering rams, tending to pull or push over the supports, particularly if the periods of vibration were different for the opposing supports.

To prevent excessive edge pressure on the reinforced concrete columns at the anchor end of the trusses, due to the slope at the end panel joint, a  $\frac{1}{8}$ -in. lead plate was inserted between the bearing and shoe-plates. Lateral and vertical deformations,

based on Williot diagrams, checked very closely with the actual horizontal movement over the rollers (maximum,  $\frac{3}{8}$ -in.) and the vertical deflections (maximum,  $2\frac{3}{16}$ -in.).
